historic structure report
the main building

ELLIS ISLAND
STATUE OF LIBERTY

NATIONAL MONUMENT/NEW YORK-NEW JERSEY

**Beyer Blinder Belle/
Anderson Notter Finegold**

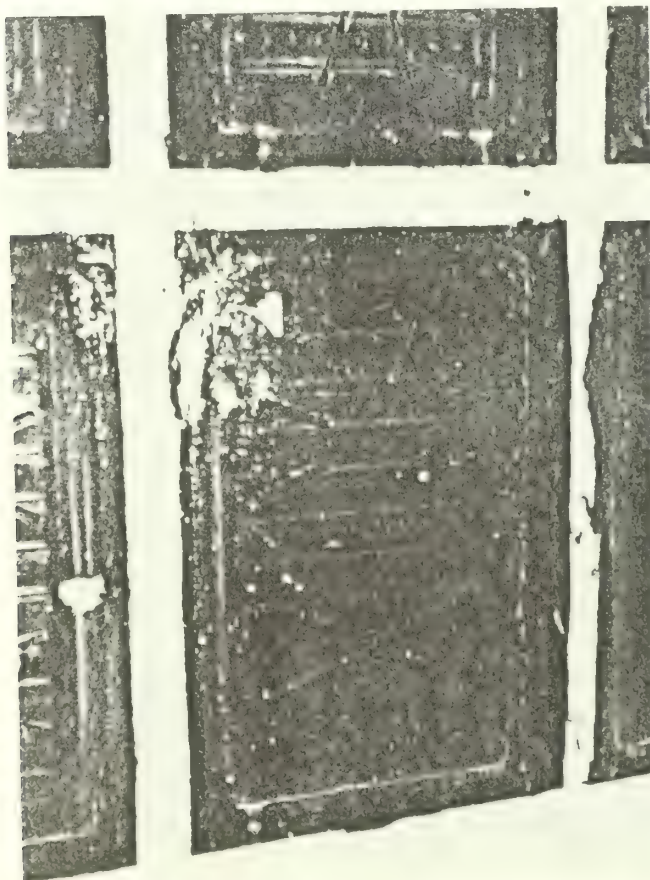
10. Deterioration of skylight frame, railroad ticket office.

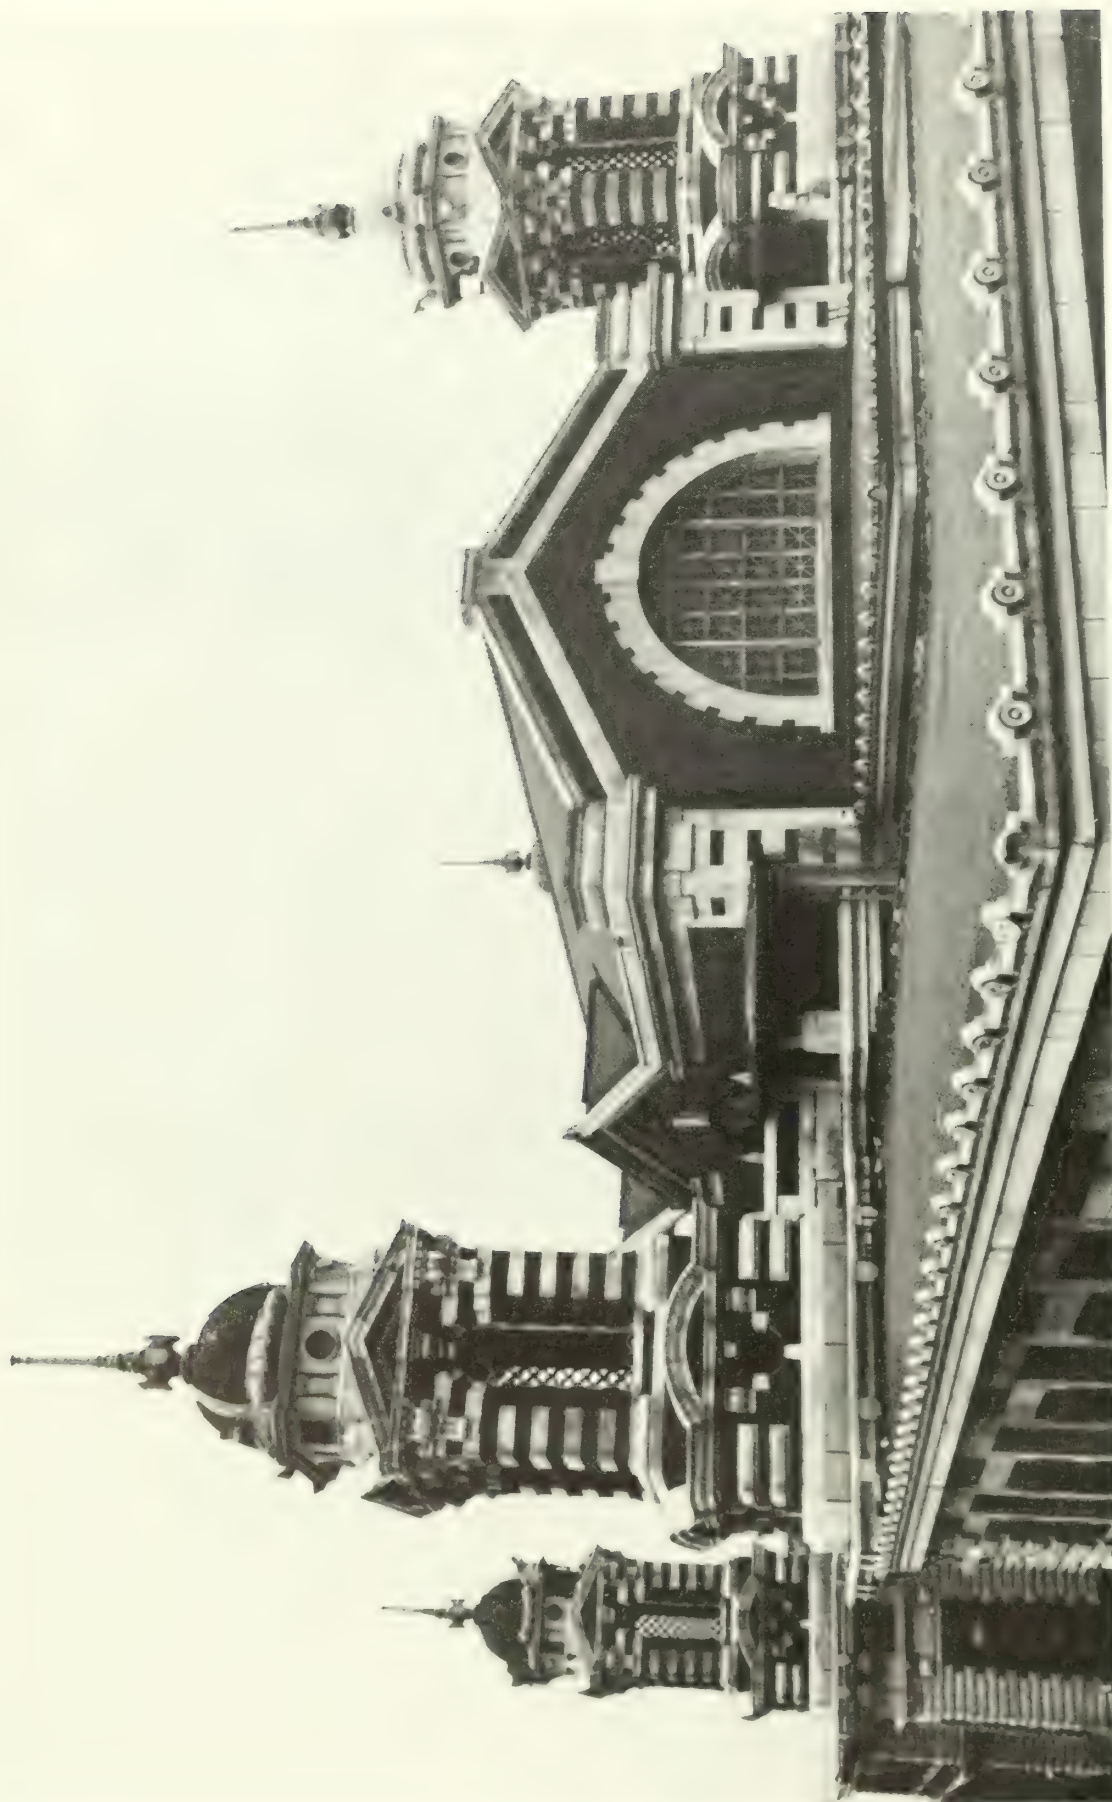
1. View of West Wing Roof, Clerestory Roof, and 4 corner Towers on the Main Building, Ellis Island. Remains of the original Ornamental Copper in situ on the Tower Domes, Clerestory Cornices, and West Wing Cornices. Date: Circa June, 1974.

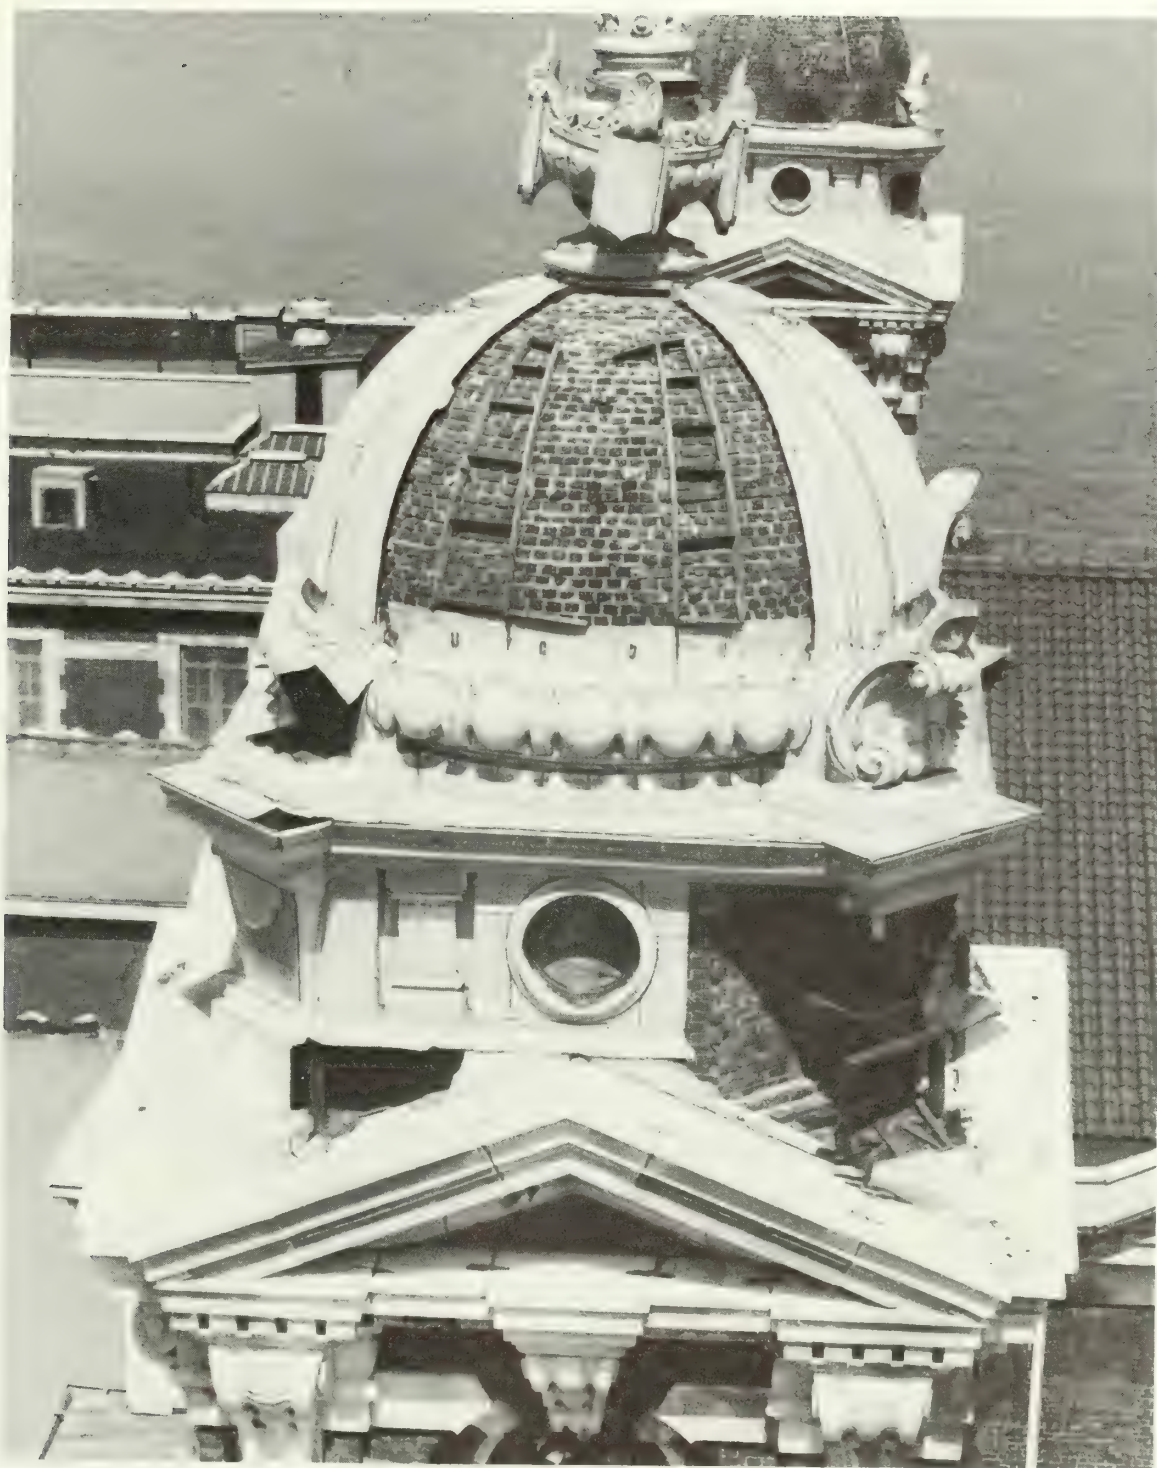
2. South Facade (aerial view) of original Ornamental Copper of the Brick dome of the Southwest Tower. Date: 1977, prior to removal and salvage of copper by NPS

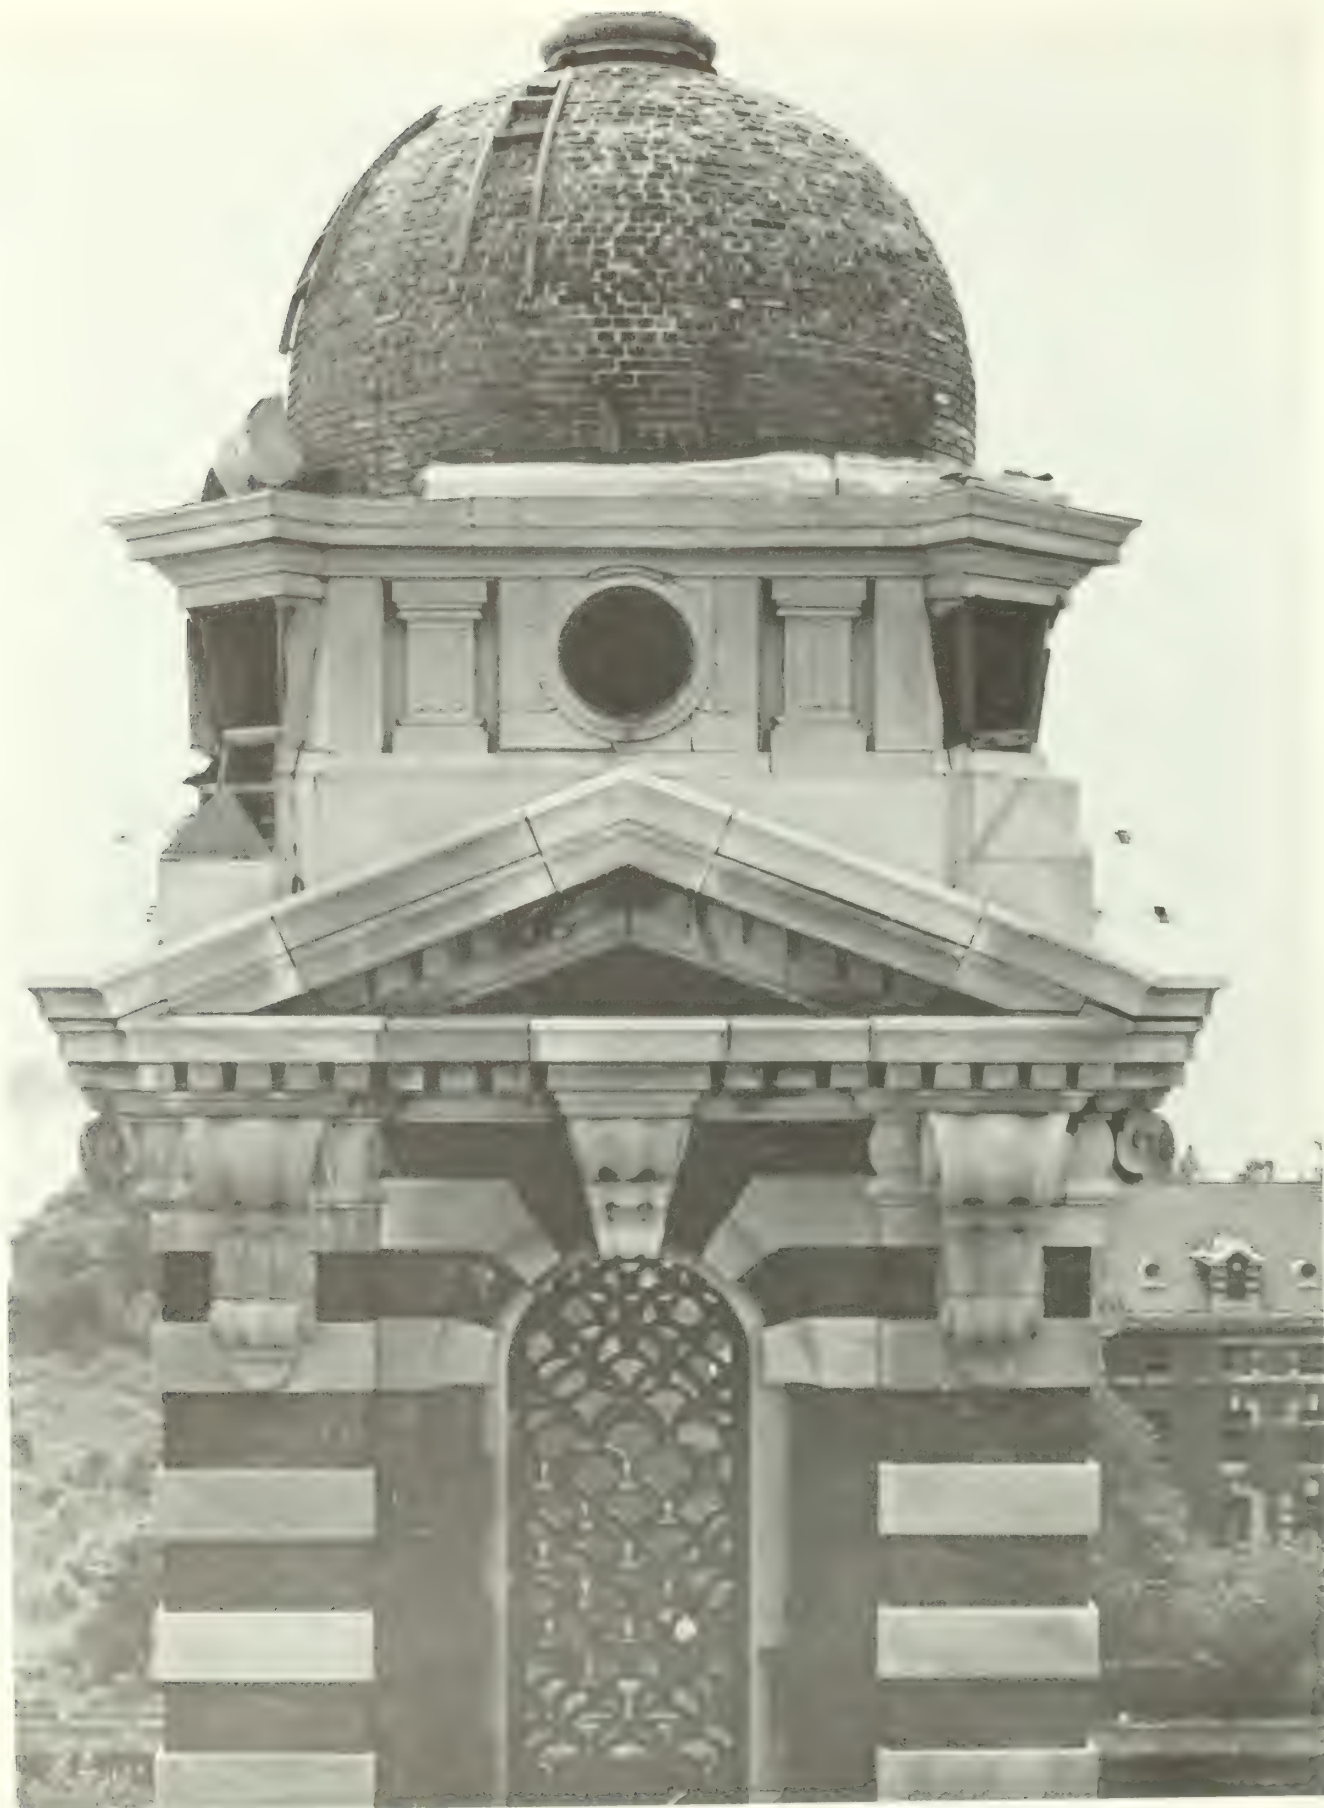
3. North Facade of Southeast Tower; original Ornamental Copper in situ.
Date: Circa 1977.

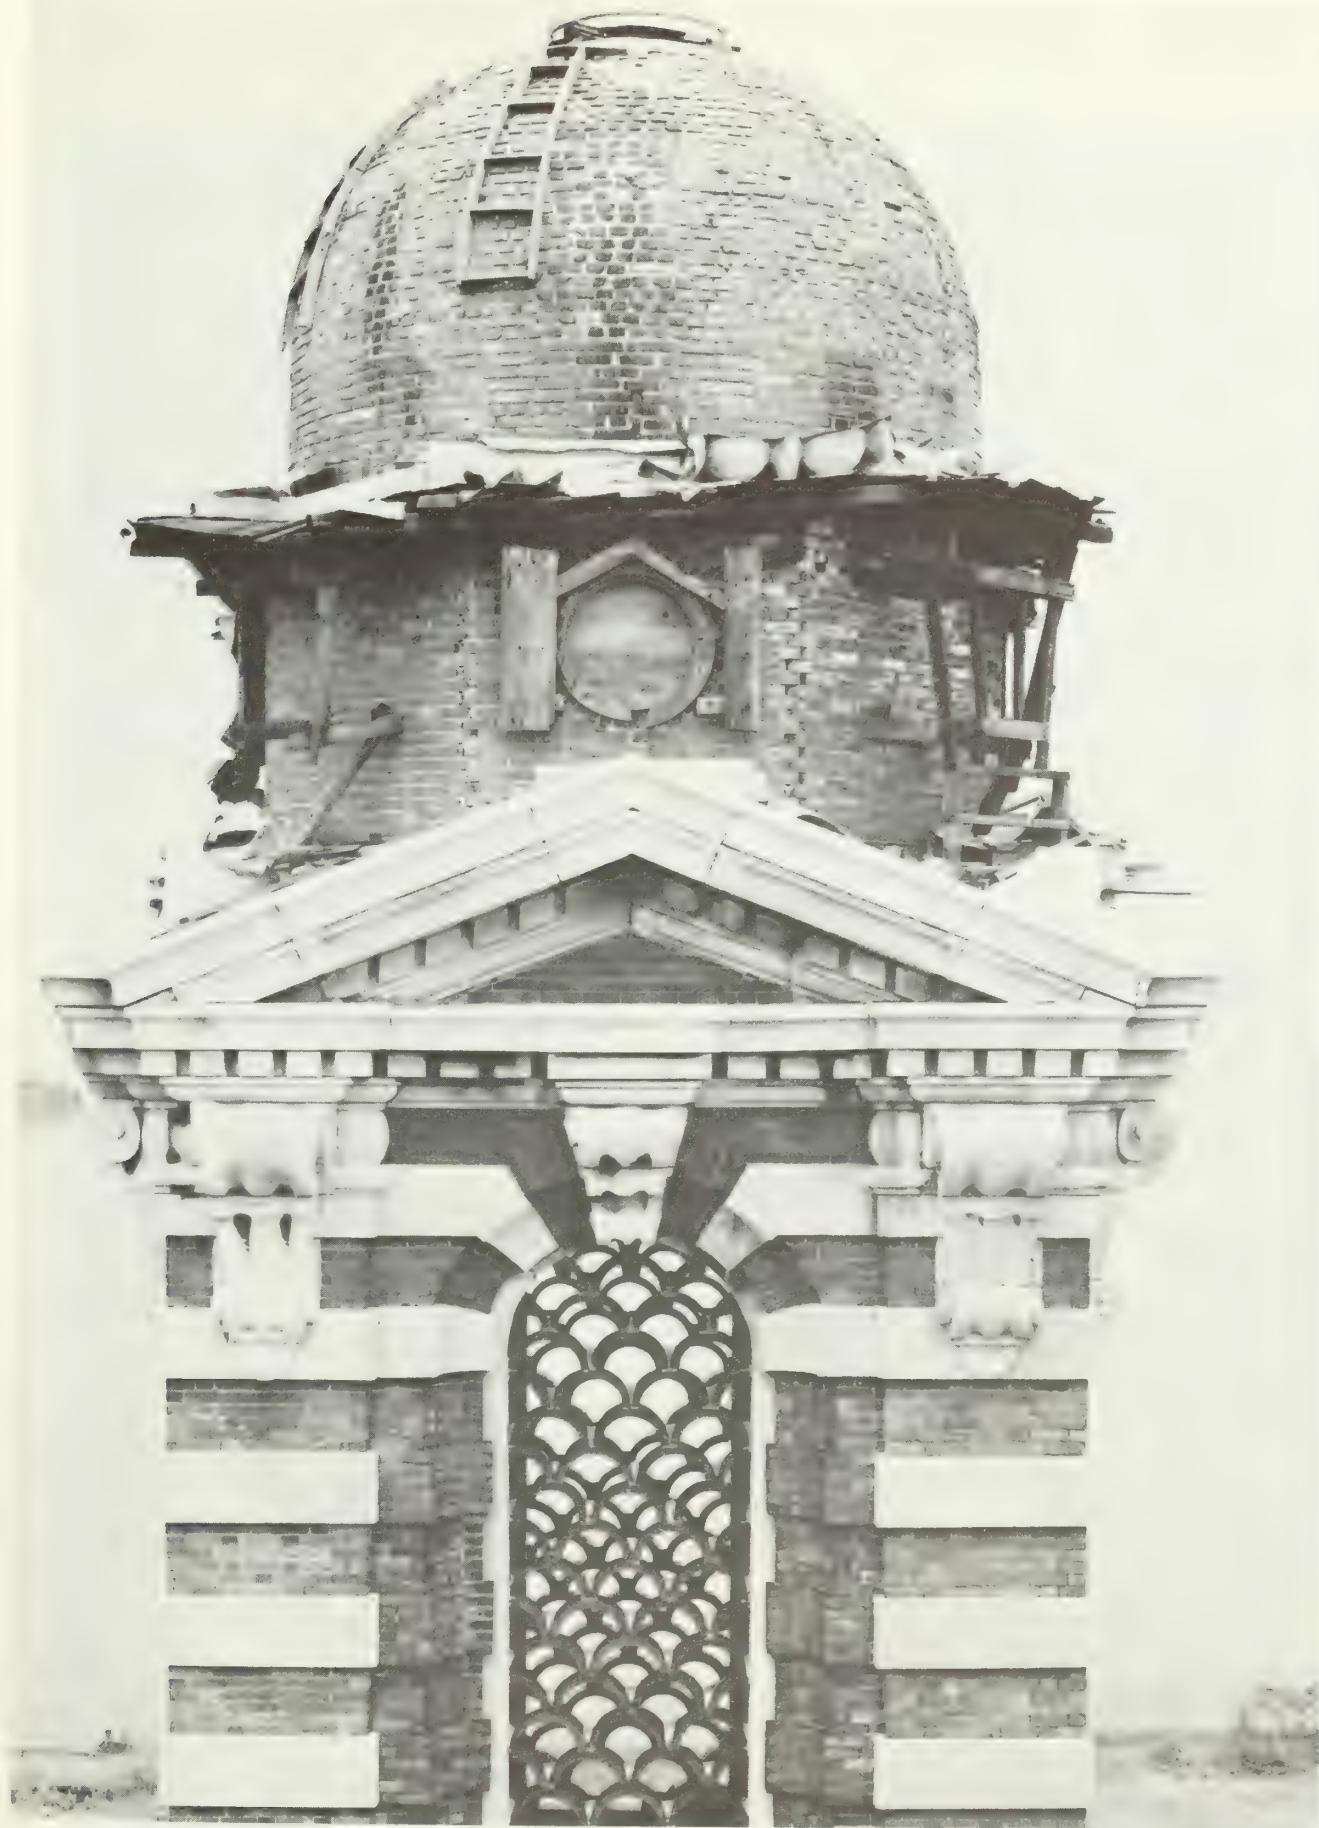
4. South Facade of Northeast Tower; original wood framing in situ on brick Dome and brick Octagonal Drum. Date: 1977.

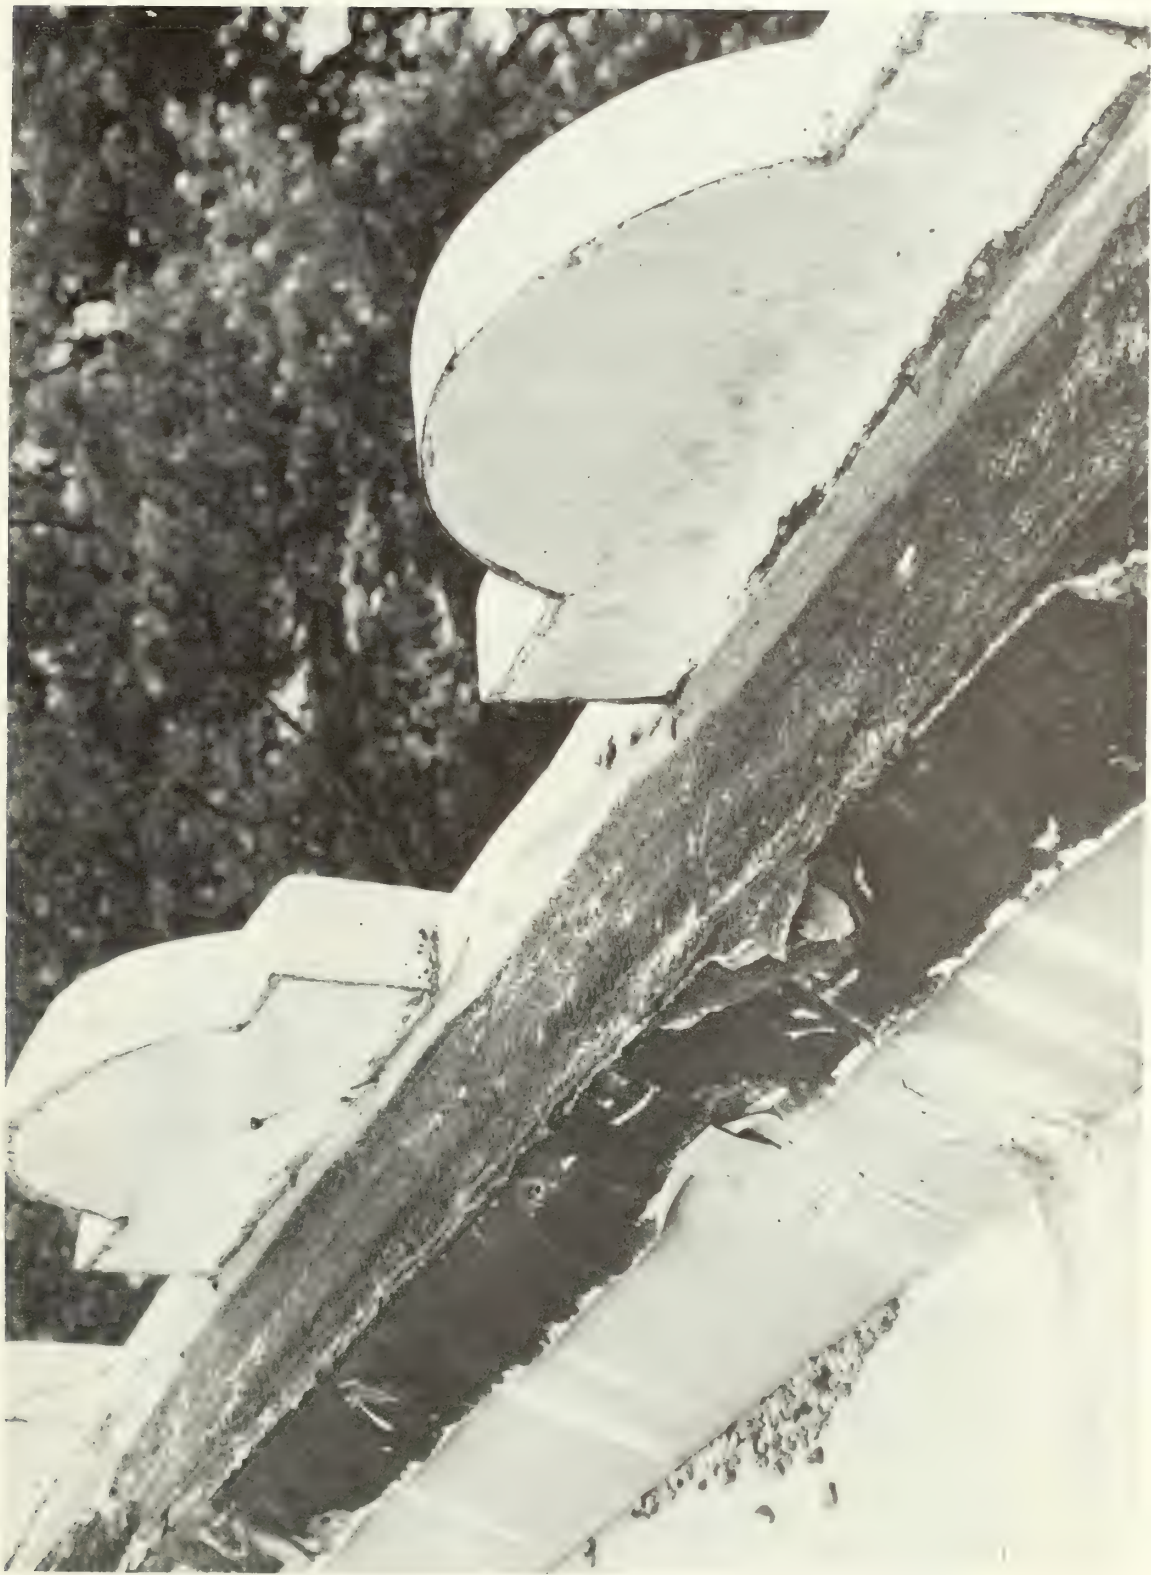
6. Original Ornamental Copper Cornices on Exterior Gutters of the Main Building Roof;
Circa 1974-77.

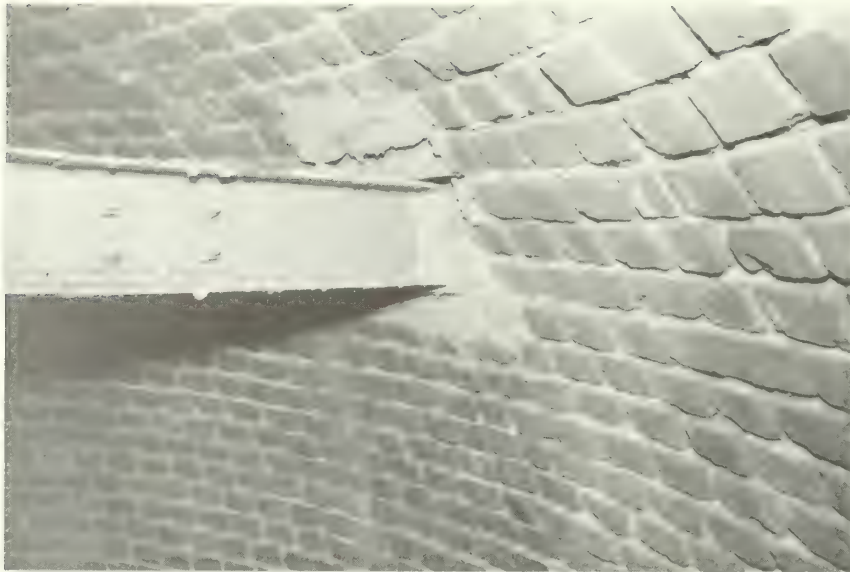
7. Original steel I beam in Brick Dome of SW Tower;
support for existing pipe column. Existing
conditions; August, 1982.

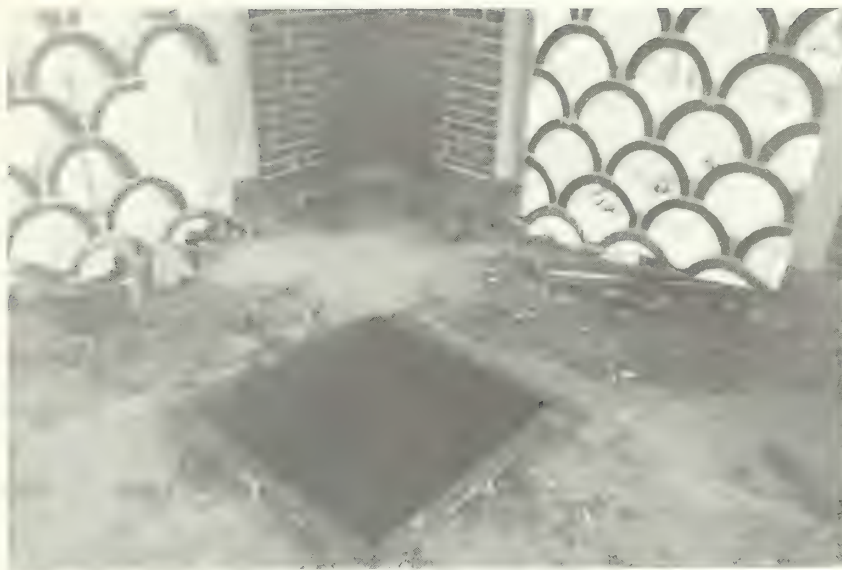
9. Hatchway and floor of Southwest Tower.
Existing conditions; August, 1982

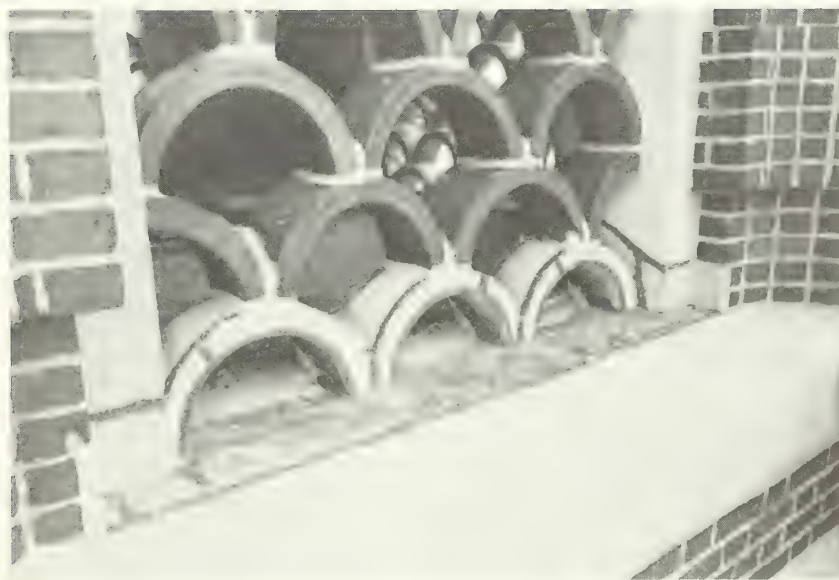
10. Copper flashing over Arch Tiles. Typical
existing conditions; August, 1982.

| ITEM | ESTIMATED QUANTITY | UNIT | UNIT PRICE | TOTAL AMOUNT |
|---|---|---|---|---|
| Repair of copper flashings over arch tiles on all four towers, 16 arches @ 50 S.F. = 800 S.F. | 800 | S.F. | 3.00 | \$ 2,400.00 |

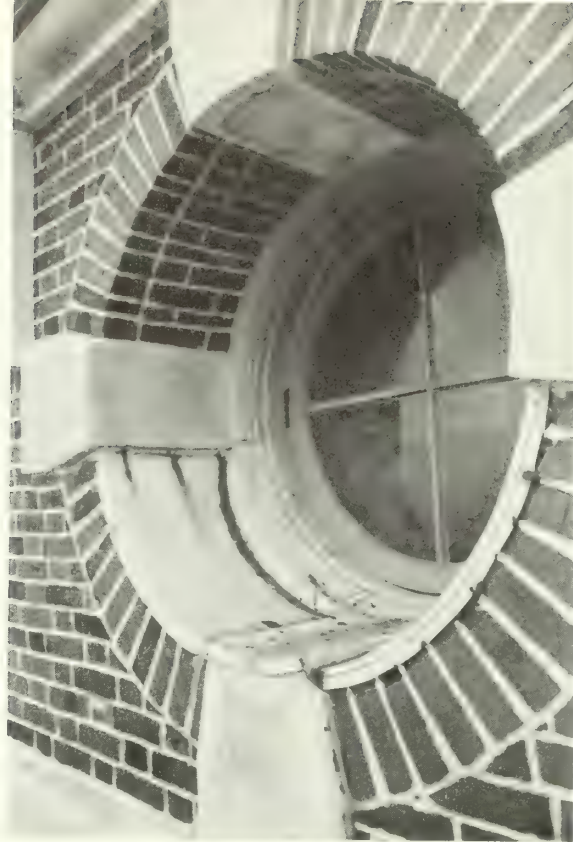
11. Exterior Copper sill flashing on Circular Tower Windows. Typical existing conditions; August, 1982

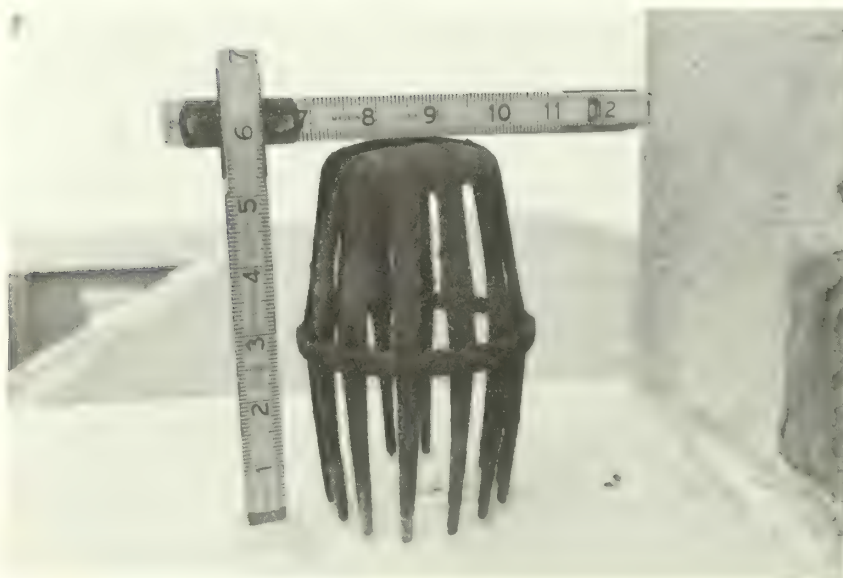
12. Typical copper alloy gutter/downspout strainer. Date: 1982

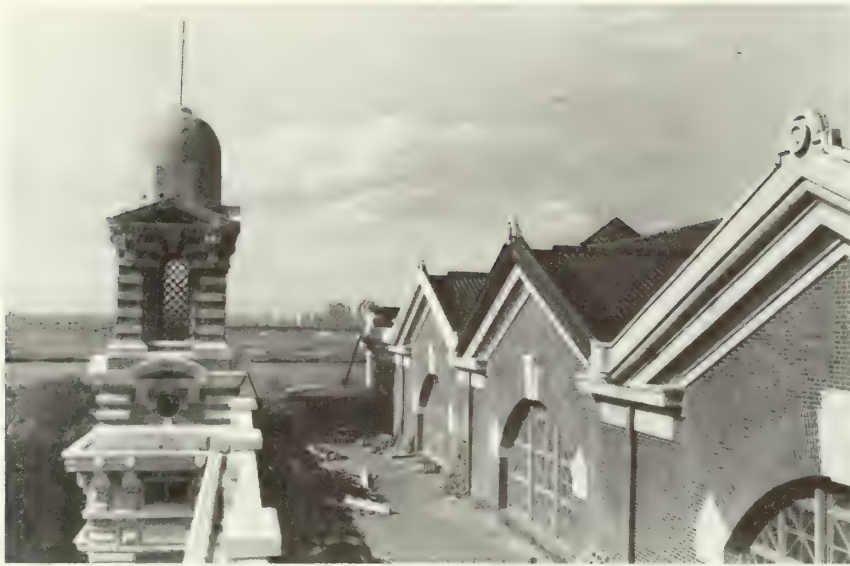
13. View west along Copper Cornice of Clerestory Roof, Balustrade Gutter, towards N.W. Tower. Existing conditions; August, 1982

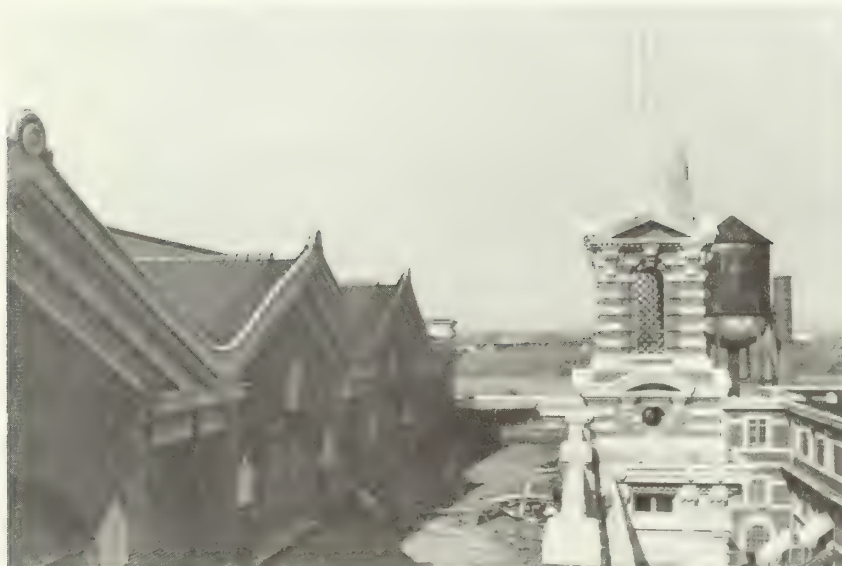
14. View west along Copper Cornice of Clerestory Roof, Balustrade Gutter, towards N.W. Tower. Existing conditions; August, 1982

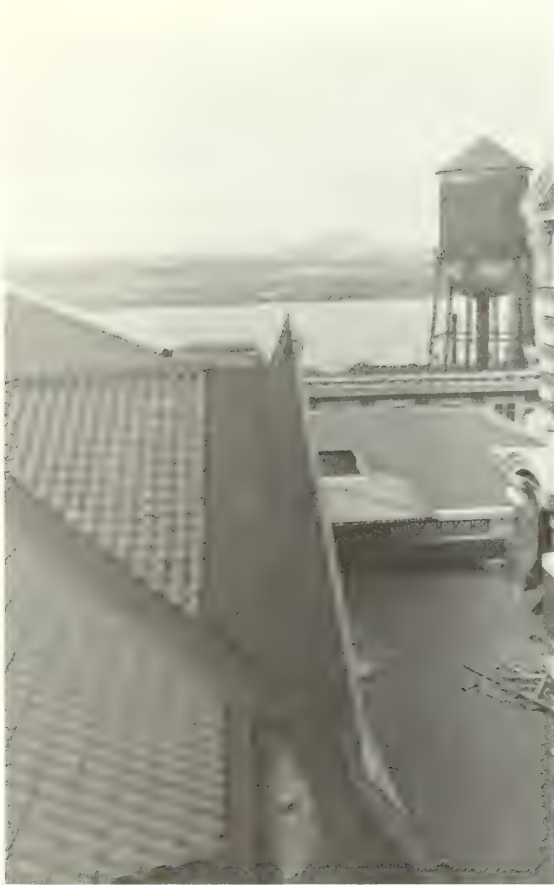
15. View west along Copper Cornice and Gutter, north side of Clerestory Roof, showing existing conditions of Bitumen over copper gutters; August, 1982.

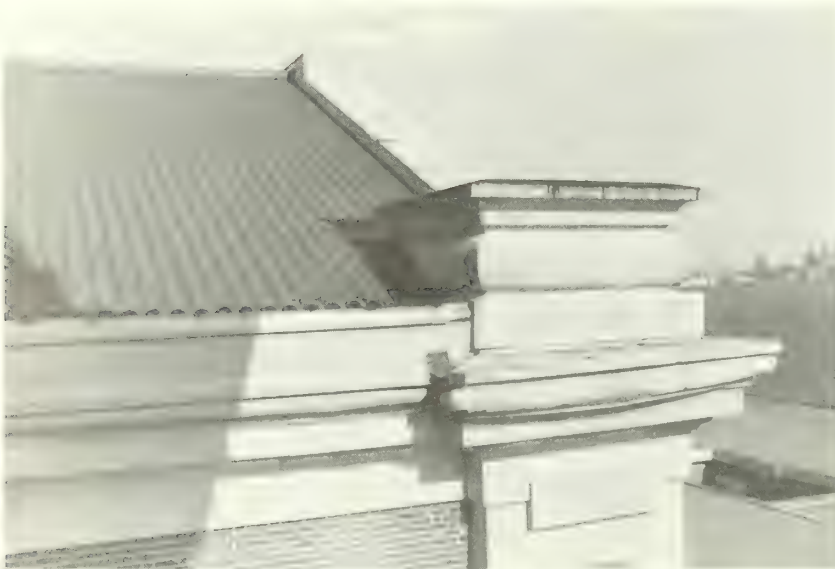
16. Southeast corner of Clerestory Roof, showing existing conditions of Clerestory Roof Copper Cornice and copper sheet cap over stone base for missing Ornamental Copper Globe; August, 1982.

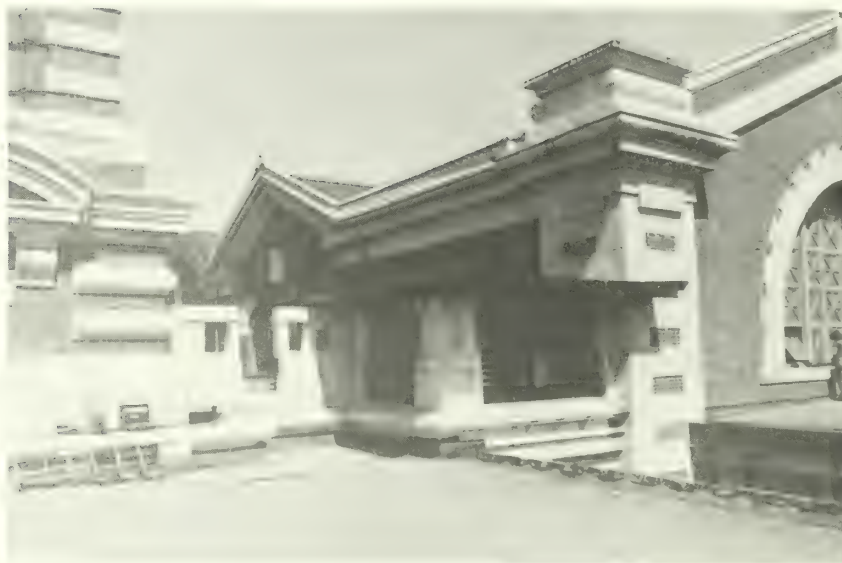
19. Southeast corner of Main Building Clerestory Roof; copper gutters, copper airshaft roof, and louvers. Existing conditions; August, 1982.

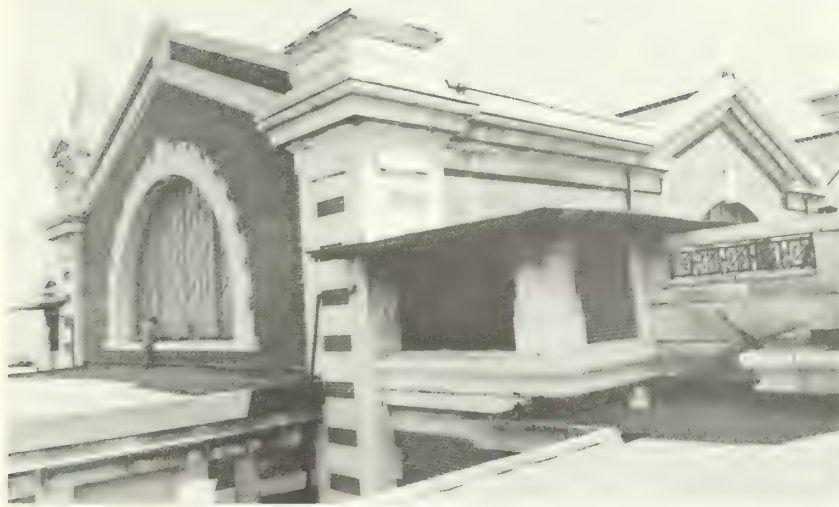
20. Southwest corner of Main Building Clerestory Roof; copper gutters, copper airshaft roof, and louvers. Existing conditions; August, 1982.

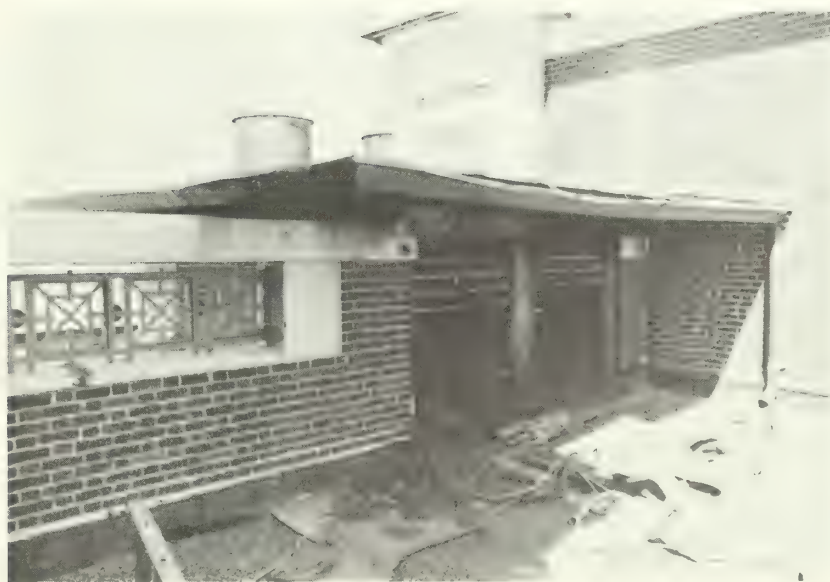
21. Southwest Airshaft Roof - standing seam copper roof, copper gutters, copper louvers, and copper downspouts. Existing conditions; August, 1982.

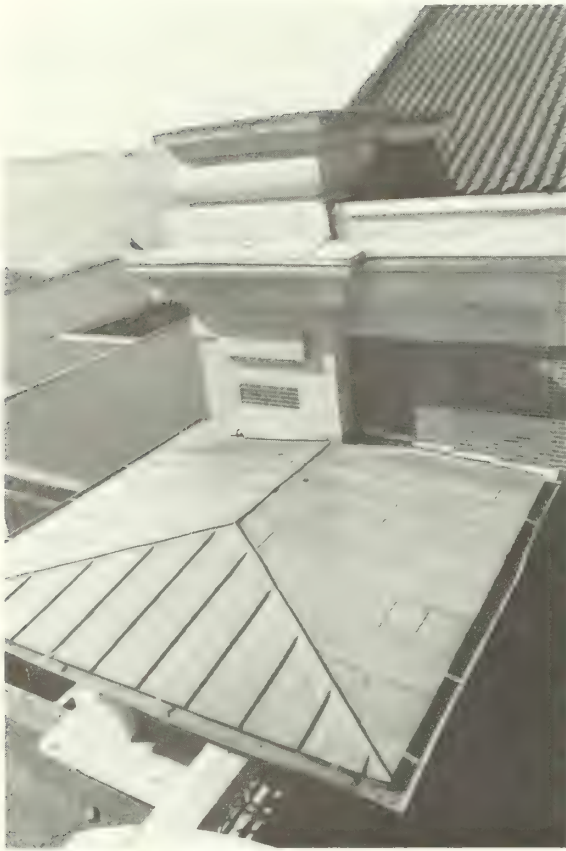
22. Northeast corner of Main Building Clerestory Roof; copper cap on stone base, copper cornices and gutters, and copper standing seam roof. Existing conditions; August, 1982.

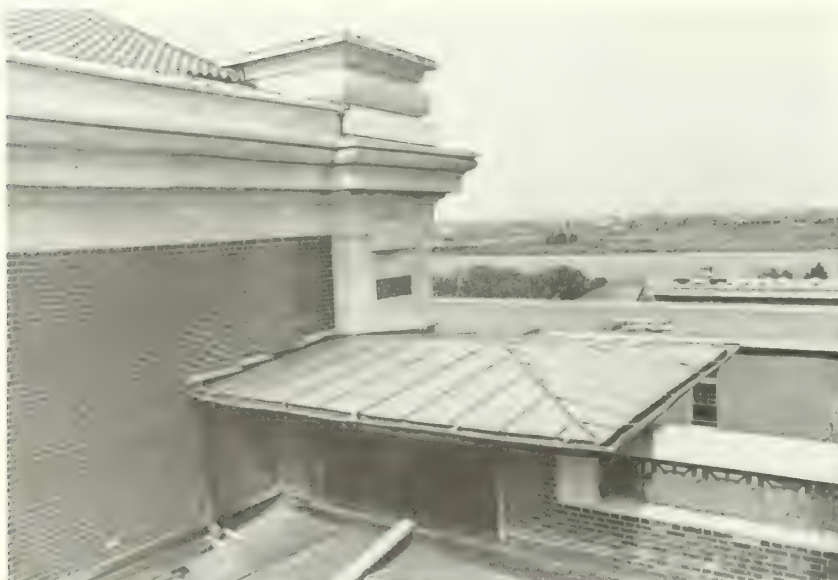
23. Northwest corner of Main Building Clerestory Roof; copper cap on stone base, copper cornices and gutters, copper standing seam roof, and copper louvers. Existing conditions; August, 1982

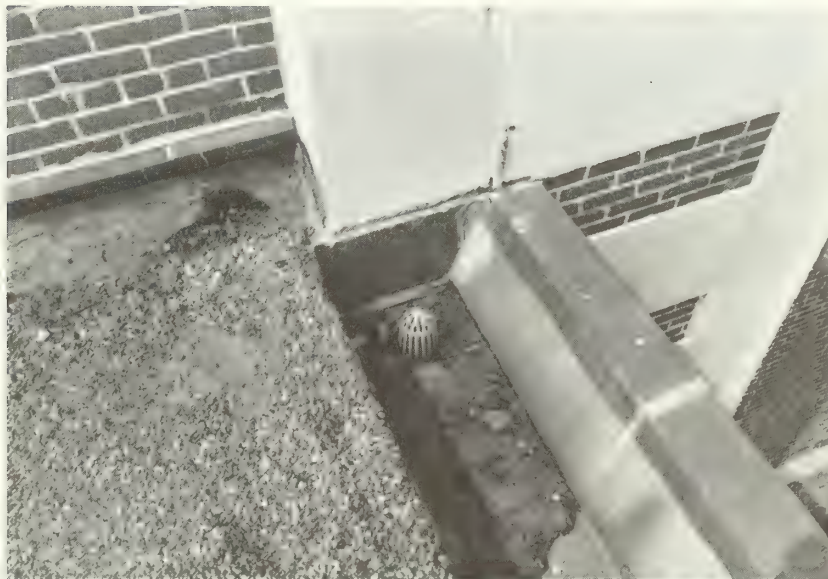
25. Interior Gutter corner drain and built up roof. Existing conditions of roof and copper on roof, East Wing; August, 1982. Original copper cornices removed, salvaged, and stored in Main Building by NPS in 1977.

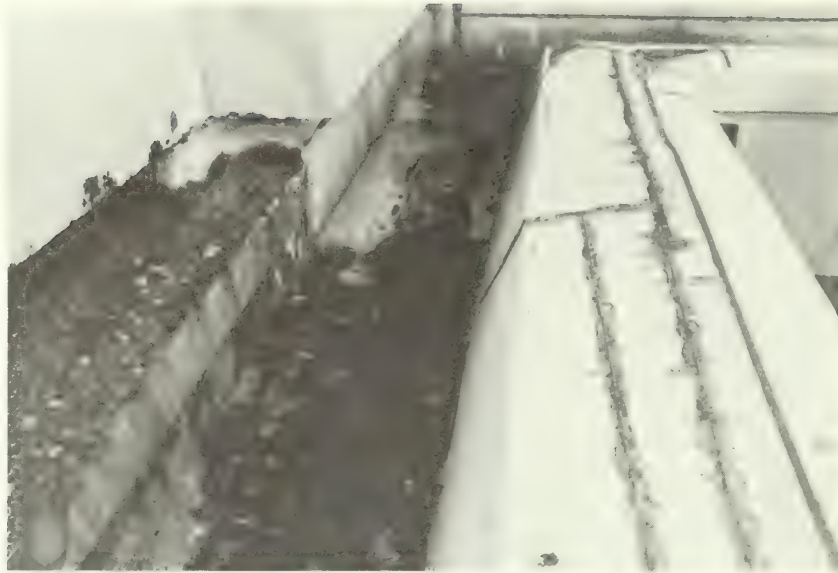
26. Balustrade Gutter. Existing conditions of original copper, loose roof gravel, spilled bitumen, and poor waterdrainage; August, 1982.

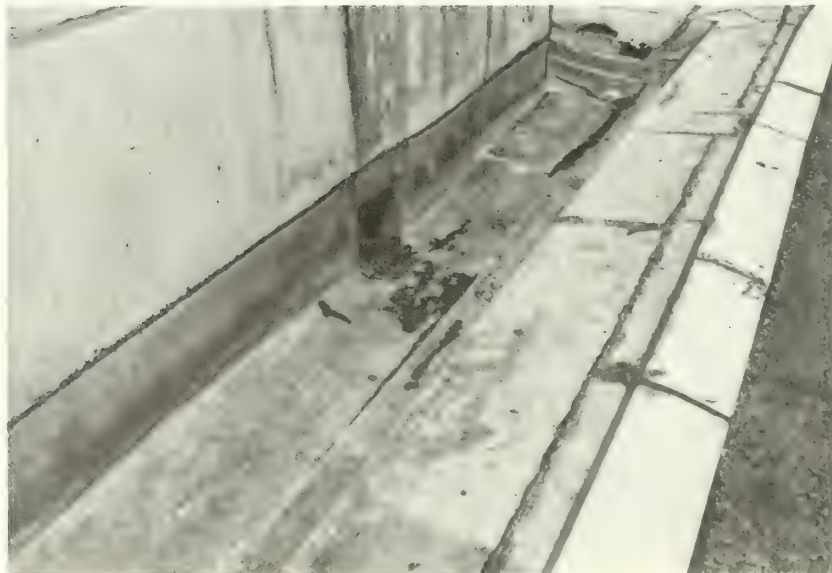
27. Tower Base Gutter. Existing conditions of original copper in stone cornice gutters; August, 1982.

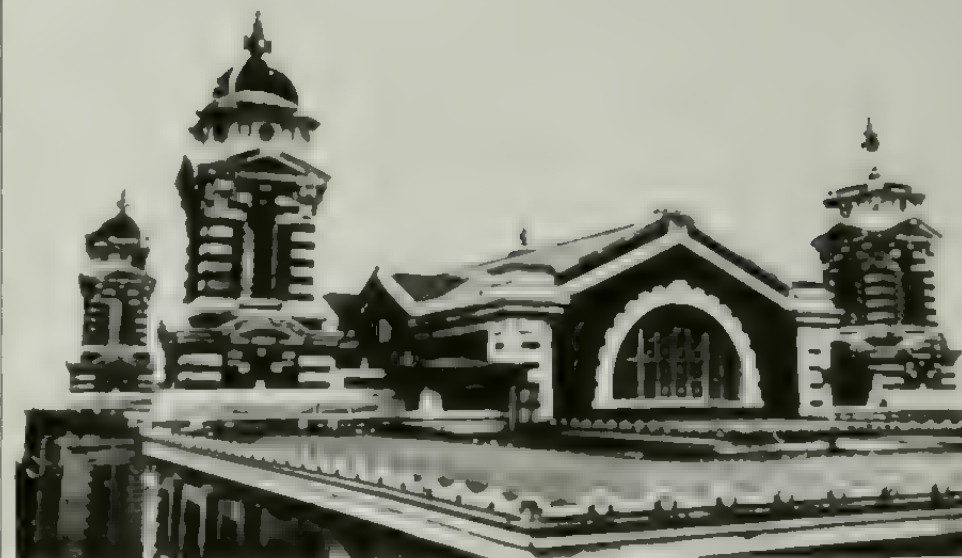
PHOTOGRAPH JUNE 26, 1974 SHOWING VIEW OF WEST WING ROOF, CLERESTORY ROOF AND FOUR TOWERS OF THE ELLIS ISLAND MAIN BUILDING WITH SOME OF THE ORIGINAL (HISTORIC) ORNAMENTAL COPPER FEATURES STILL INTACT. THE ORNAMENTAL COPPER GLOBES FOR THE CLERESTORY ROOF CORNER STONE BASES ARE MISSING
